Field Report for Airborne Data Collected In Support of US EPA Region 6 KMCO Fire – Flight 2 3 April 2019

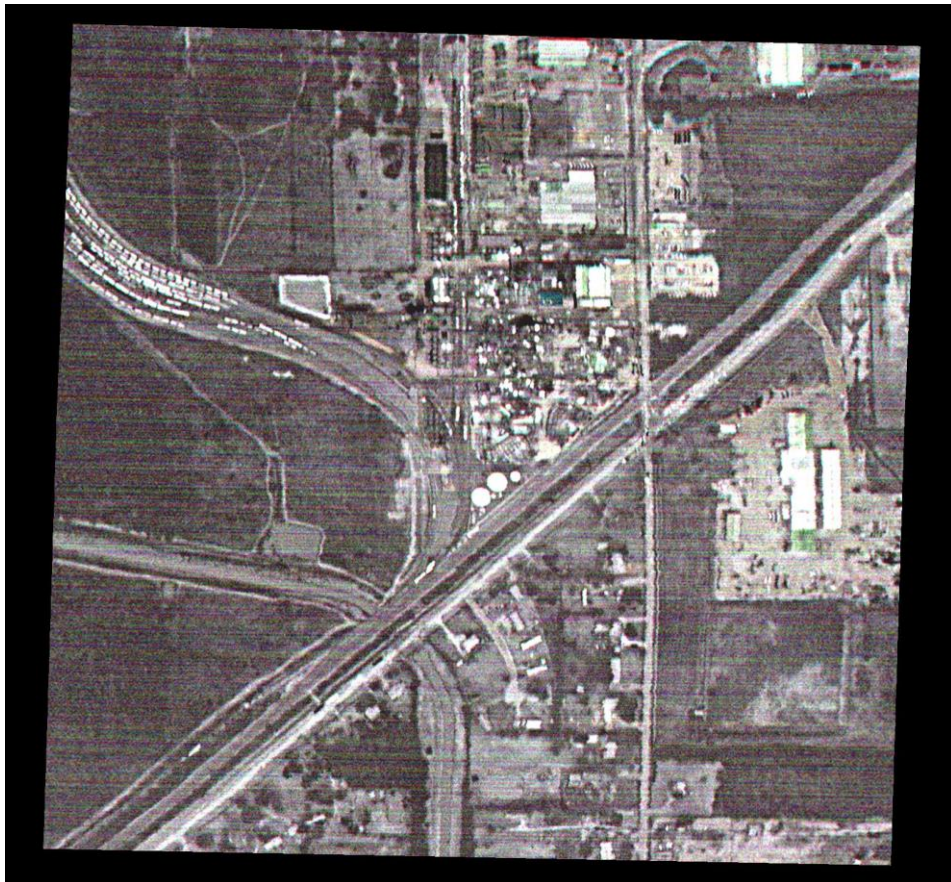
A total of 1 test and 5 data passes were made in the proximity of the fire and an infrared line scanner image was generated for each pass. Figure 3 shows a 3-band infrared image obtained from data collected for Run 3. This image was generated by flying directly over the facility. Analysis of the images showed no significant elevated temperature areas and no plumes being emitted from the facility.

Figure 3: – 3 band IR image, KMCO Fire, Flight 2, Pass 3

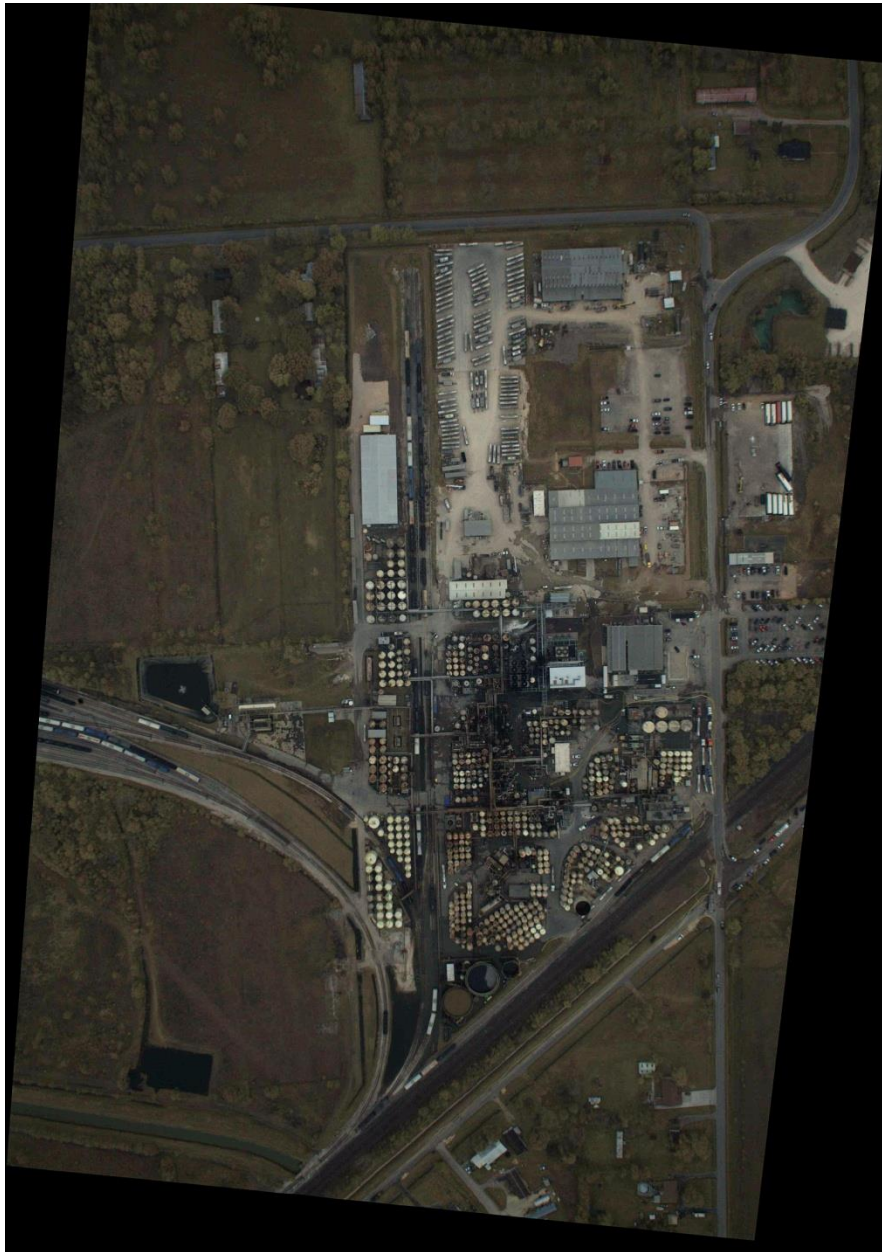
A full set of high resolution aerial digital photography were collected as part of the flight. Figure 4 shows an image collected as part of each pass. The burned area in the center of the facility is evident but no smoke is being emitted from the facility. Figure 5 shows an oblique collected during the flight. As with the aerial image, evidence of damage caused by the fire is present with no active smoke or emission being emitted from the facility.

Figure 4: Aerial Image of the KMCO Fire

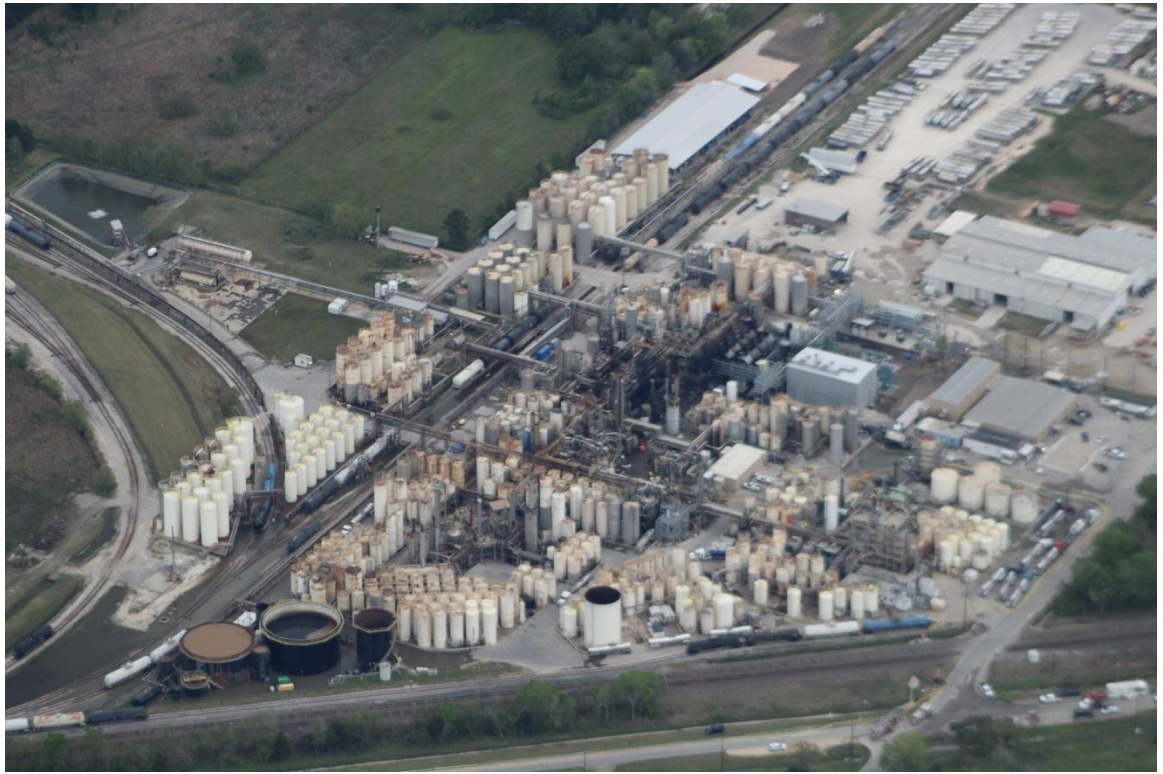
Figure 5: Oblique Image of the KMCO Fire
